G-III-C-181

Clarence Wilt Farm
Private
New Germany vic.

INVENTORY FORM FOR STATE HISTORIC SITES SURVEY

Clarence Wilt Farm

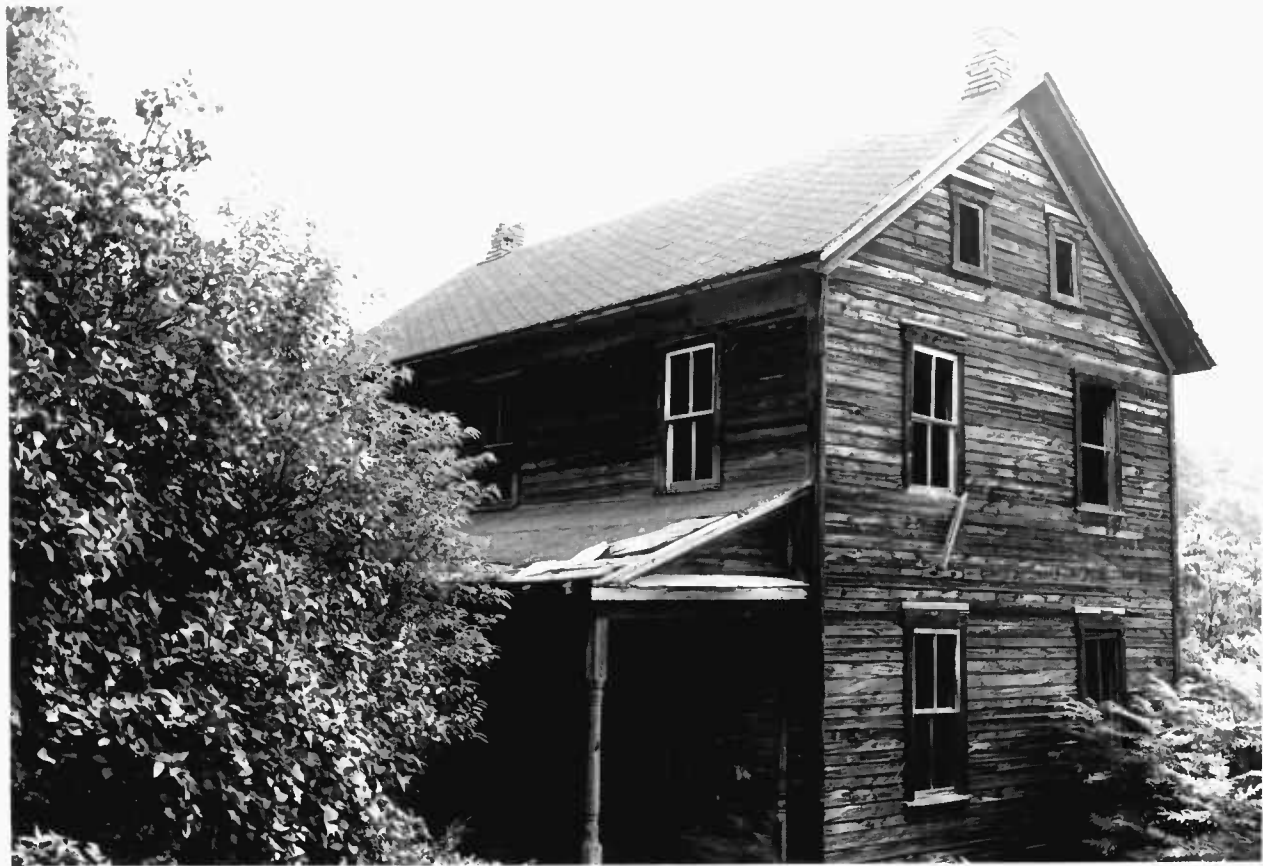
G-III-C-181

The Clarence Wilt farmhouse is a two story, three-bay by two-bay structure with a gable roof.

The original, unpainted German siding is still exposed, framed with corner boards.

W & S elevation
